# **FINAL ENVIRONMENTAL IMPACT STATEMENT**

## **Volume 3: Appendices**

### **Proposed Reconstruction and Expansion of Jamaica Bus Depot**

**Jamaica, Queens, New York**

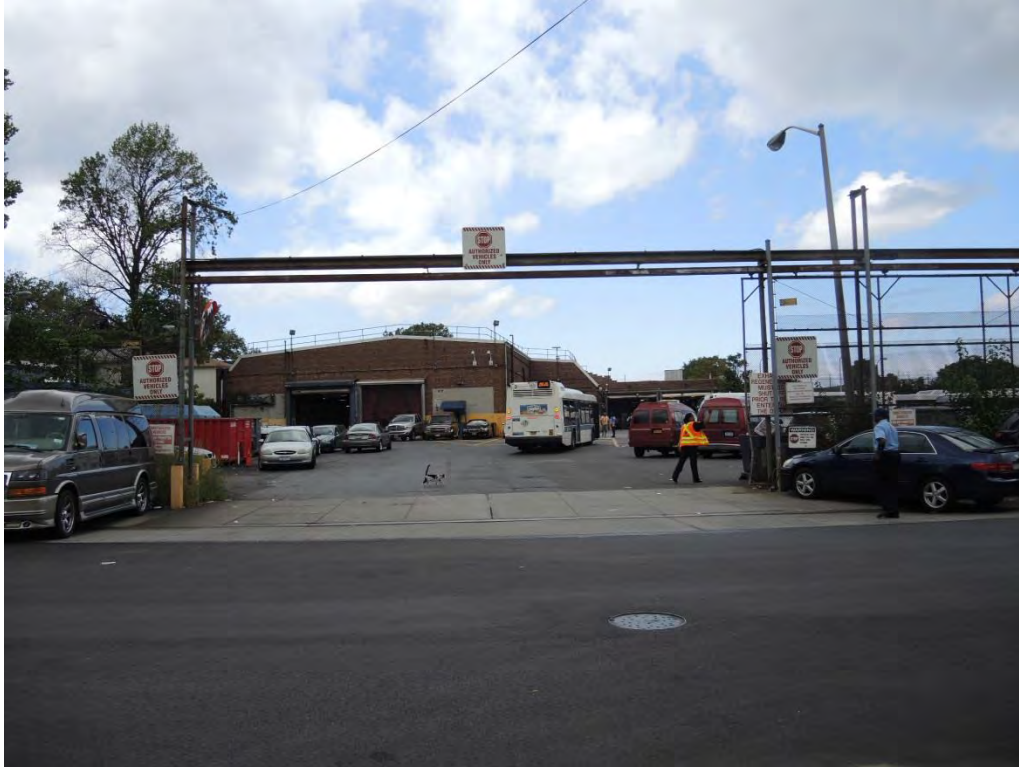
Photograph 5: Lot 46, rear of Jamaica Bus Depot. Manhole in street marks approximate former location of creek channel, which ran along the northeastern side of Lot 46. View looking northwest from 107<sup>th</sup> Avenue.

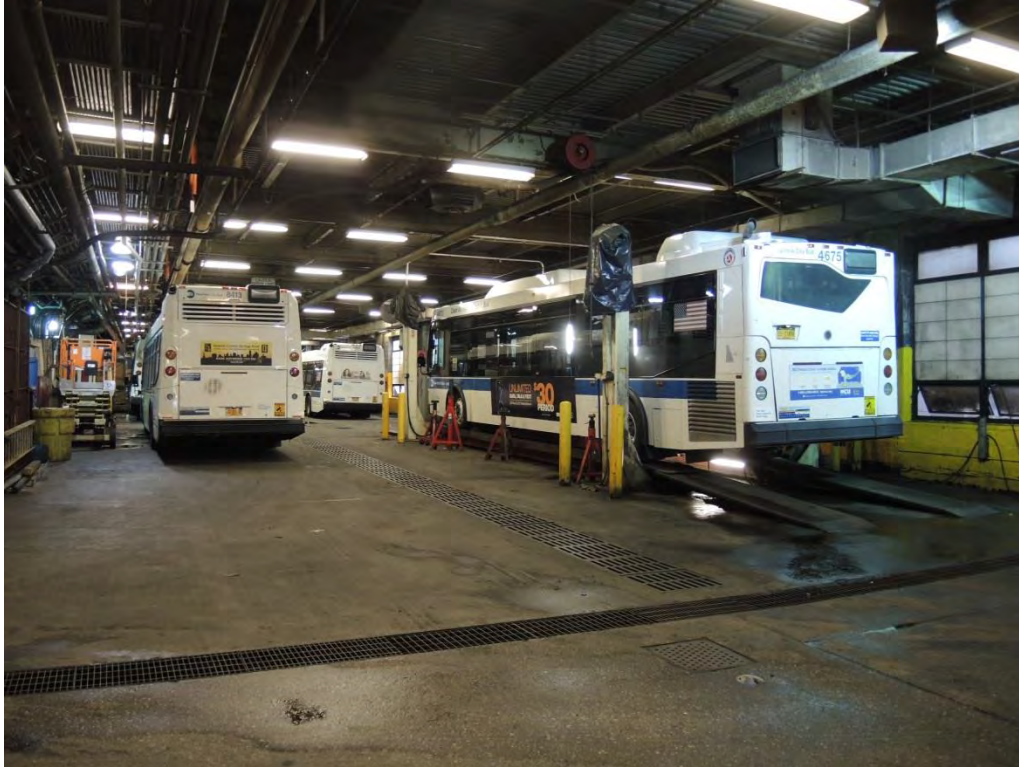
Photograph 7: Lot 46, interior of bus wash area of Jamaica Bus Depot. Note drainage grates in foreground. View looking northwest.

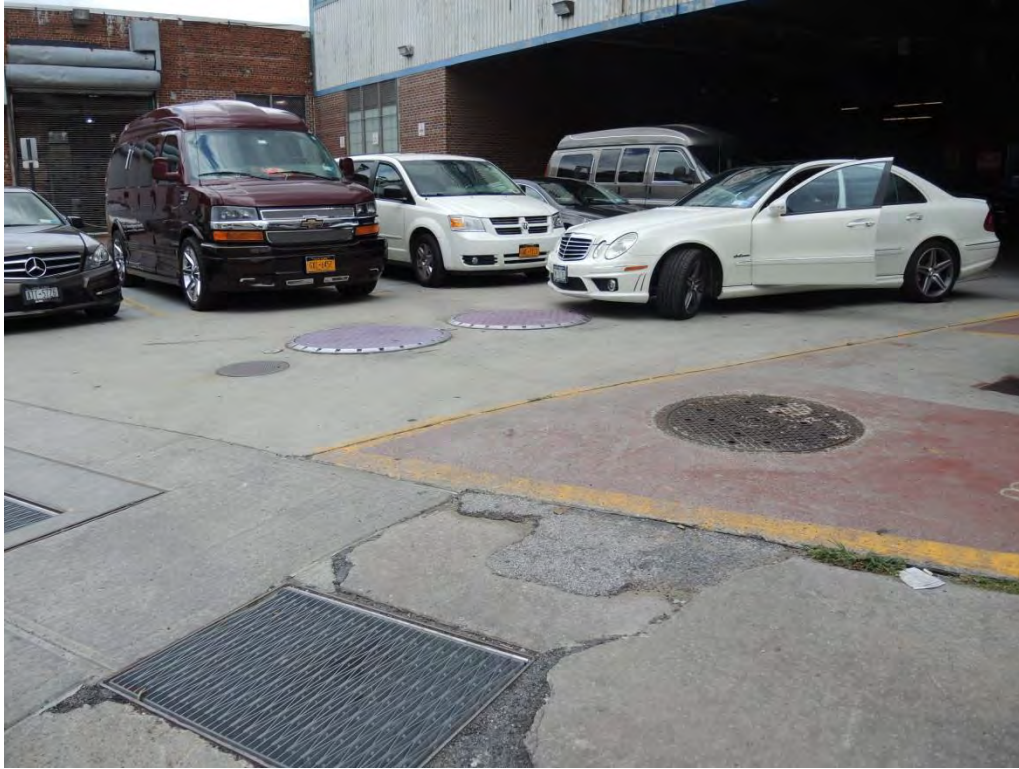
Photograph 9: Lot 46, detail of manholes and grates leading to buried tanks and other subsurface utilities at Tuskegee Airmen Way entrance to Jamaica Bus Depot. View looking southeast from Tuskegee Airmen Way.

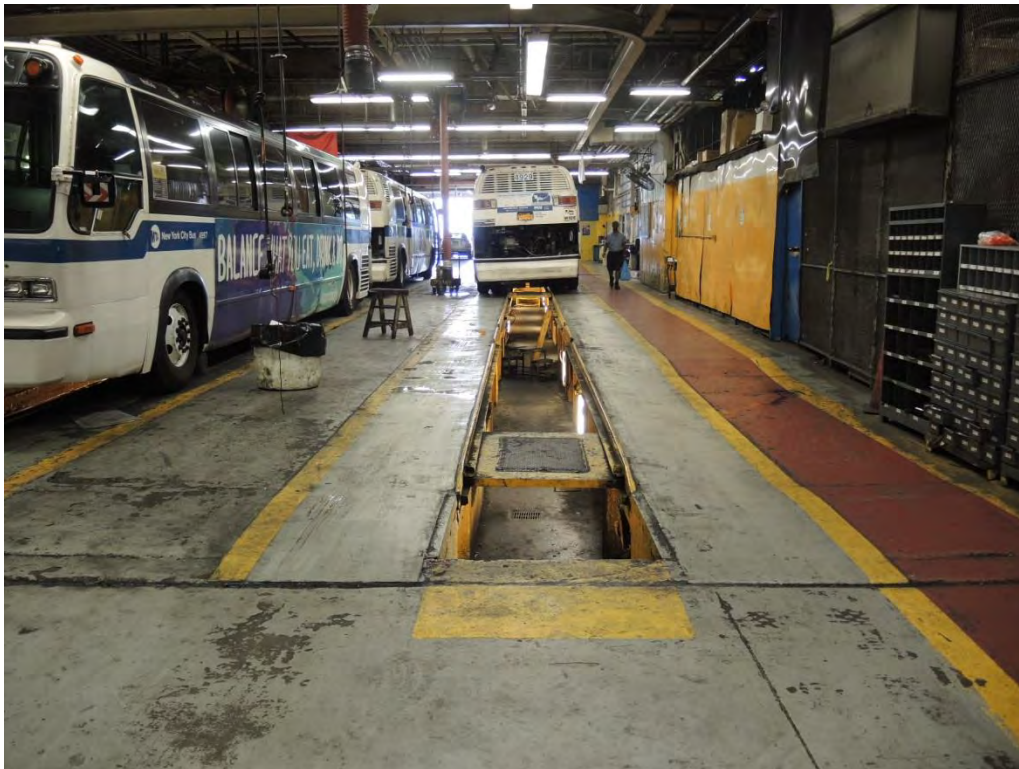
Photograph 10: Lot 46, example of subgrade pit for bus maintenance. View looking northwest.
