Appendix C Phase I and Phase II Environmental Site Assessments 168th Street Interim Bus Terminal

Phase I Environmental Site Assessment

Proposed MTA Jamaica Bus Terminal Facility

90-01 168 Street
Queens, New York
(Block 9800, Lot 5)

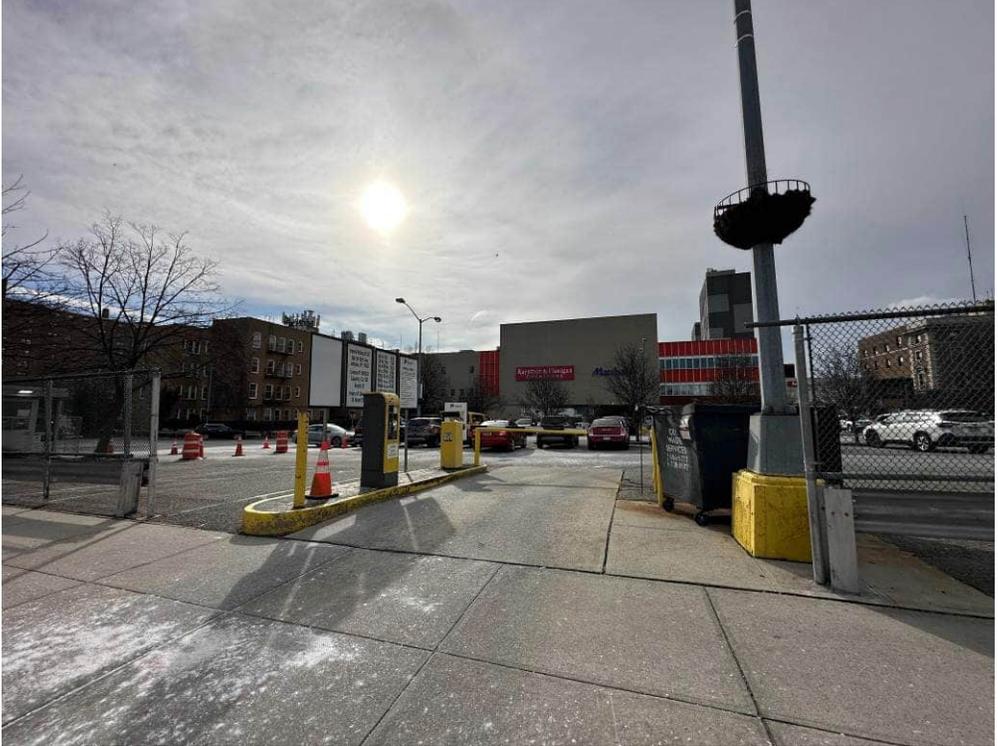
Client Name: MTA C&D		Site Location: 90-01 168 th Street, Jamaica, New York, 11432	Project No.: 60704499
Photo No.: 1	Date: 03/15/23

Direction Photo Taken: Looking South			
Description: View of Entrance Gate of Public Parking Lot (North Entrance) – Jamaica First Parking LLC

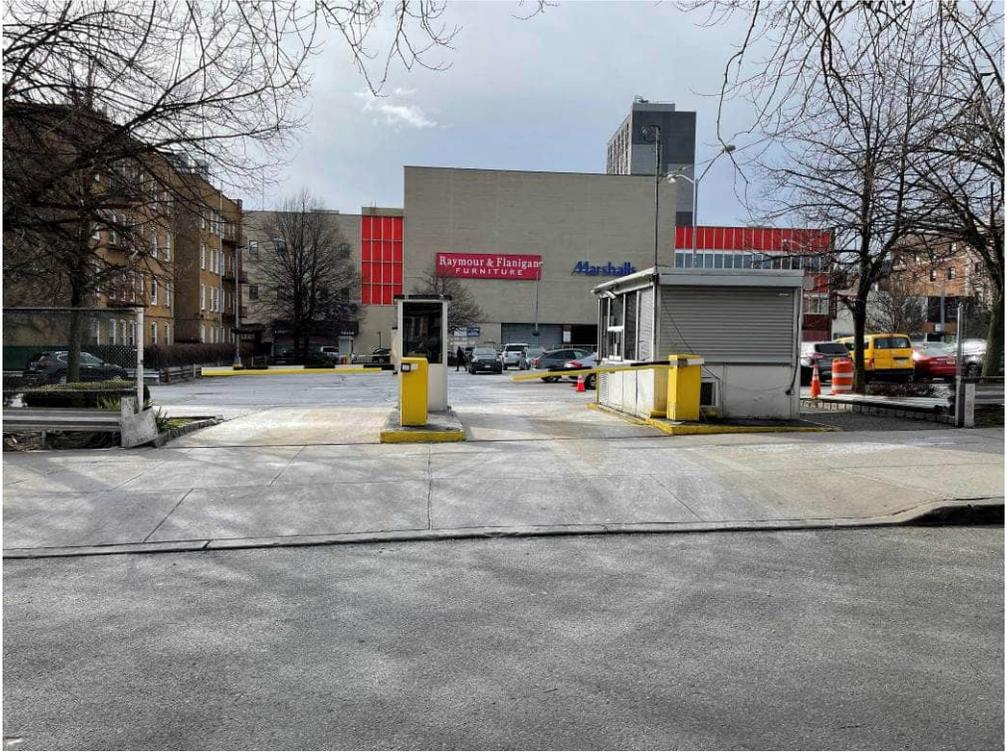
Photo No.: 2	Date: 06/03/20

Direction Photo Taken: Looking South			
Description: View of Exit Gates along 90 th Avenue and manned Attendant Booth at Exit Gate on north side of the subject property.

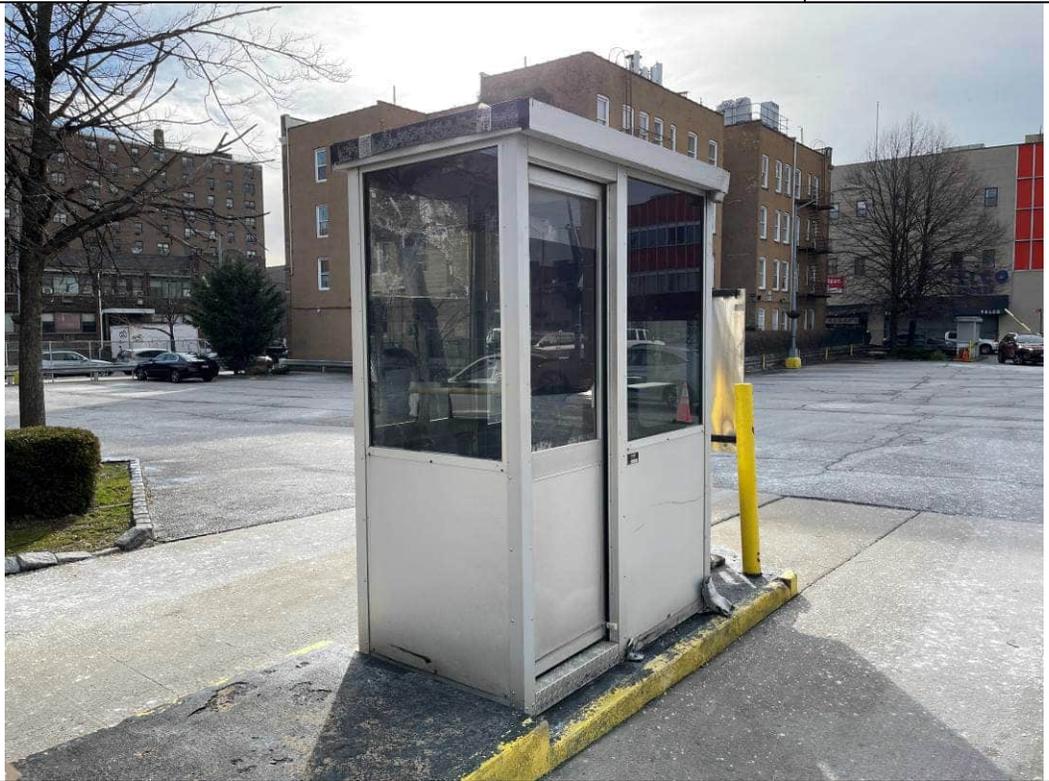
View of unmanned attendant booth adjacent to Entrance Gate on northern side of subject property.

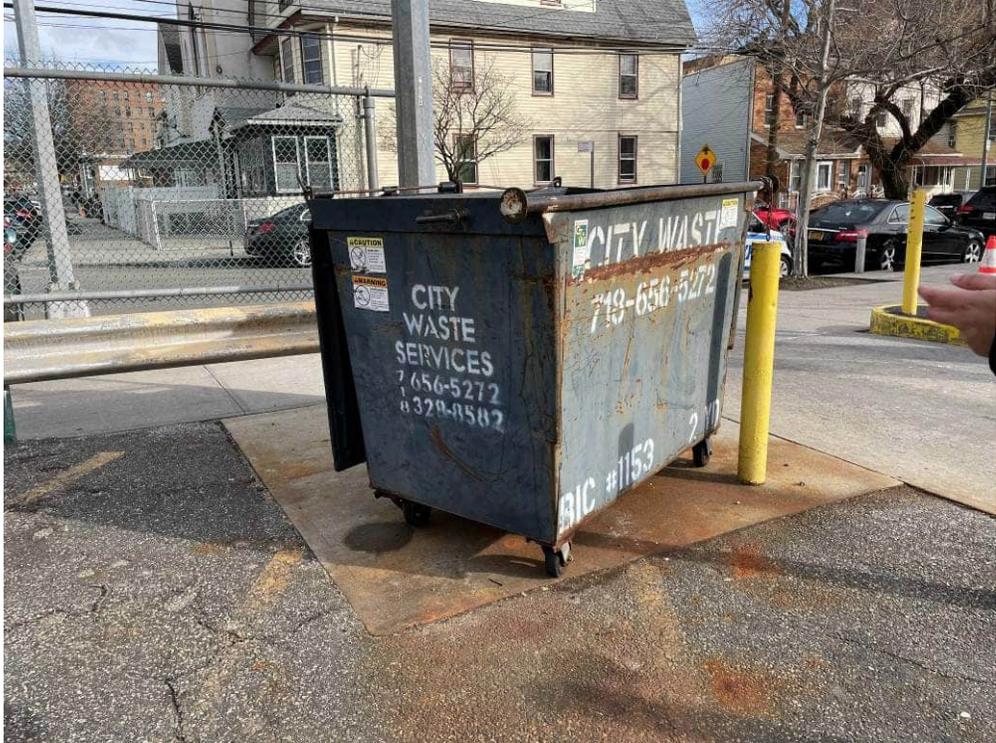
Client Name: MTA C&D		Site Location: 90-01 168 th Street, Jamaica, New York, 11432	Project No.: 60704499
Photo No.: 5	Date: 03/15/23

Direction Photo Taken: Looking North			
Description: View of two-yard dumpster used for the collection of general trash. Dumpster is staged adjacent to Entrance Gate.

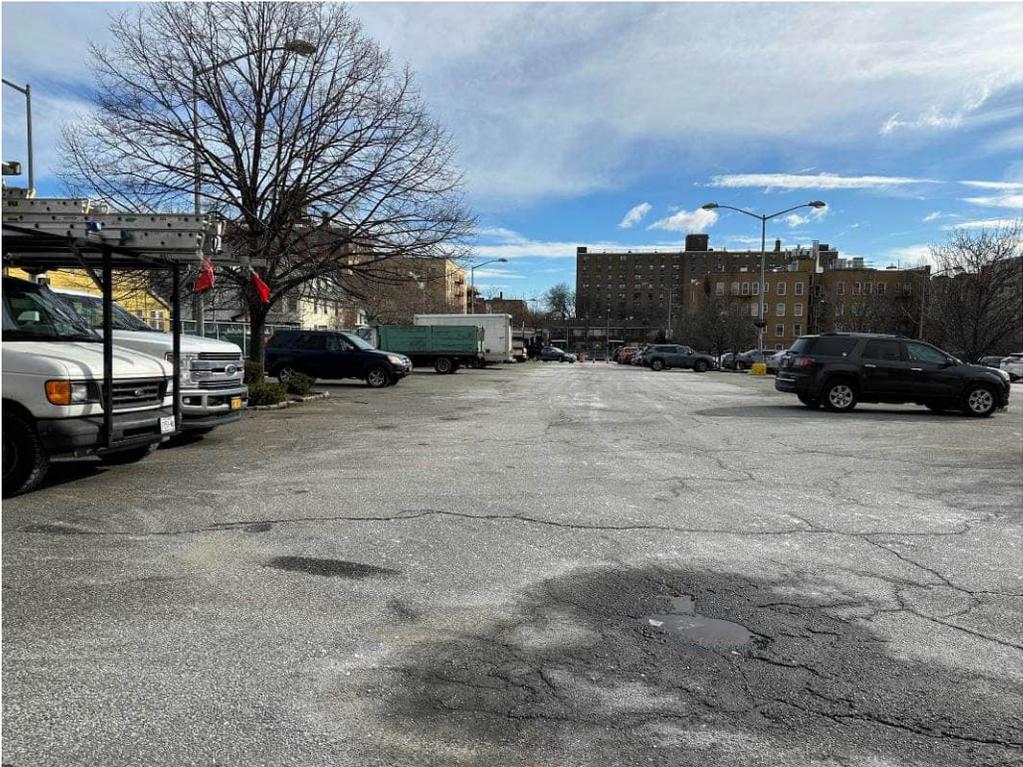
Photo No.: 6	Date: 03/15/23

Direction Photo Taken: Looking West		
Description: View of paved parking lot along northern side of subject property. Note trees and small landscaped area to the left, along northern property boundary.

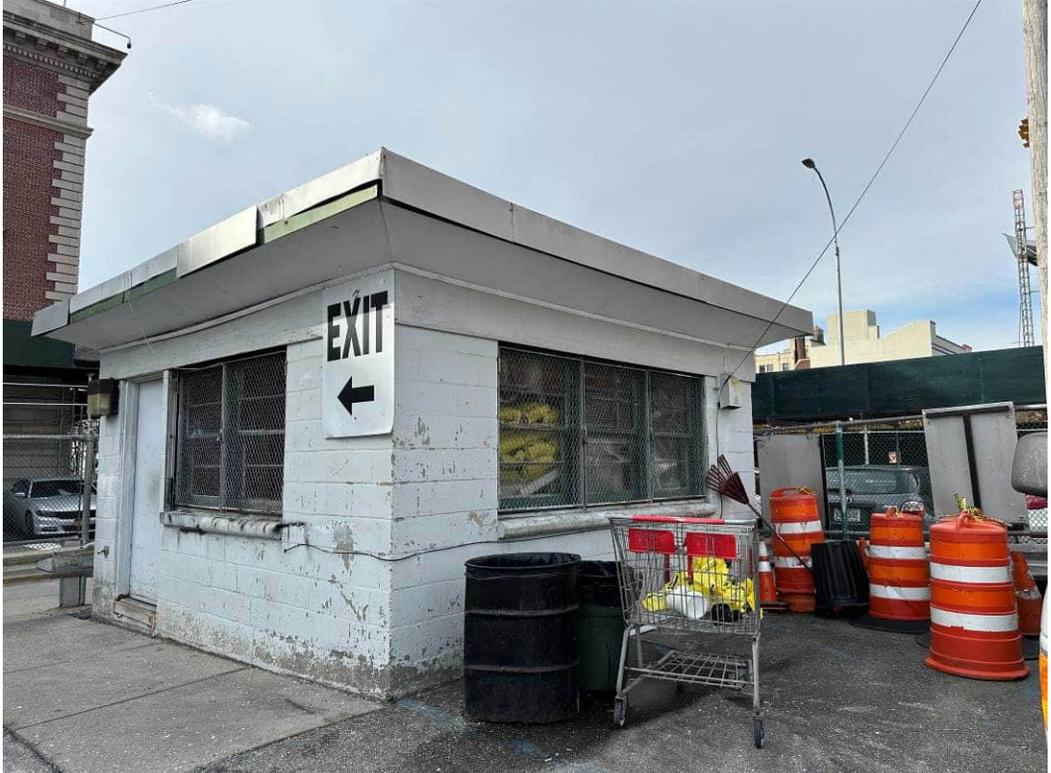
Client Name: MTA C&D		Site Location: 90-01 168 th Street, Jamaica, New York, 11432	Project No.: 60704499
Photo No.: 7	Date: 03/15/23

Direction Photo Taken: Looking West			
Description: View of cinderblock storage building located at southwest corner of subject property. Building was not accessed during site visit; however, bags of ice melt/rock salt were observed stored inside.

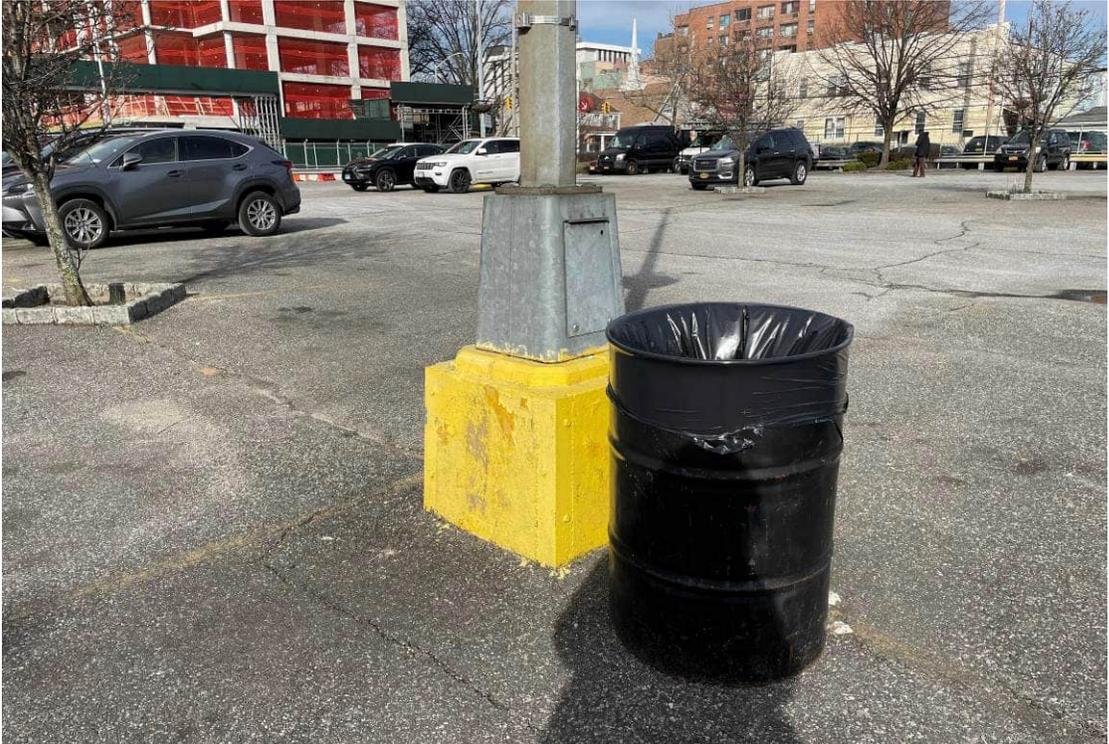
Photo No.: 8	Date: 03/15/23

Direction Photo Taken: Looking South		
Description: View of 55-gallon drums used for collecting general trash and debris. Note trees and light poles are located along centerline of parking rows.

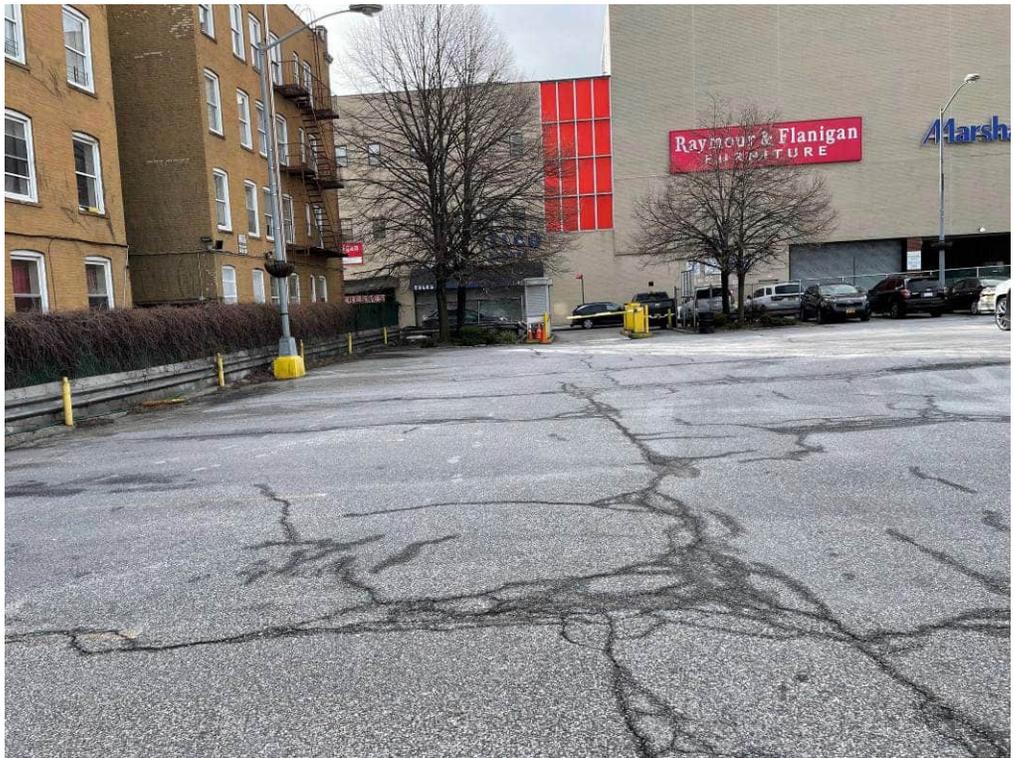
View of southeast side of the paved parking lot. Note multi-story residential building abutting southeast portion of site and retail stores across 91st Avenue to the south. Metal guardrails and chain-link fencing surround the subject property. Southern Exit Gate is un rear of photo.

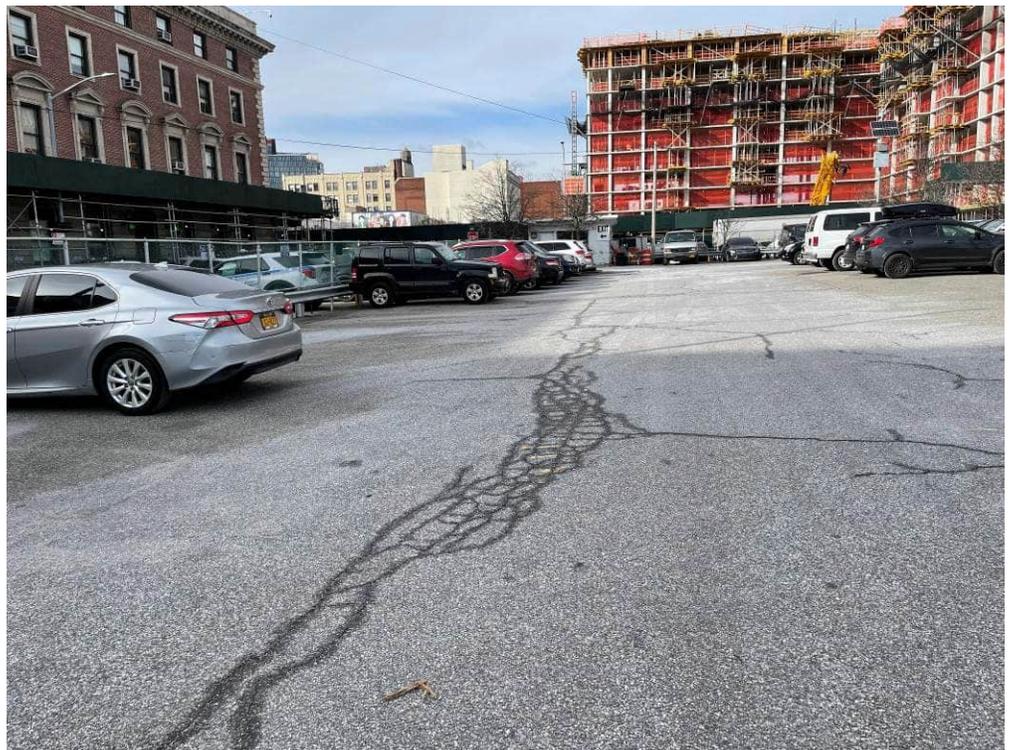
View of southern side of subject property / paved parking lot. Off site adjacent multi-story structure under construction on west side of 168th Street is depicted in the background.

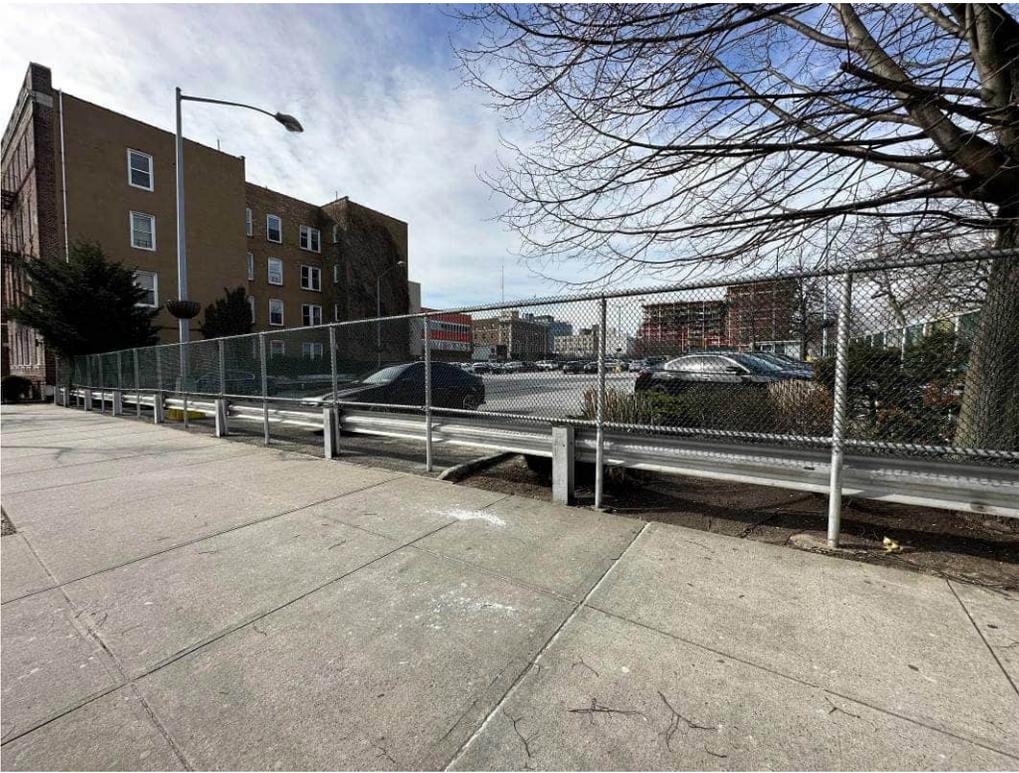
Client Name: MTA C&D		Site Location: 90-01 168 th Street, Jamaica, New York, 11432	Project No.: 60704499
Photo No.: 11	Date: 03/15/23

Direction Photo Taken: Looking East - Southeast			
Description: West side of parking lot adjacent to 169 th Street. Note metal guardrail and chain-link fencing surrounds site. Multi-Story residential structure that abuts eastern portion of subject property is depicted on the left side of the photograph.

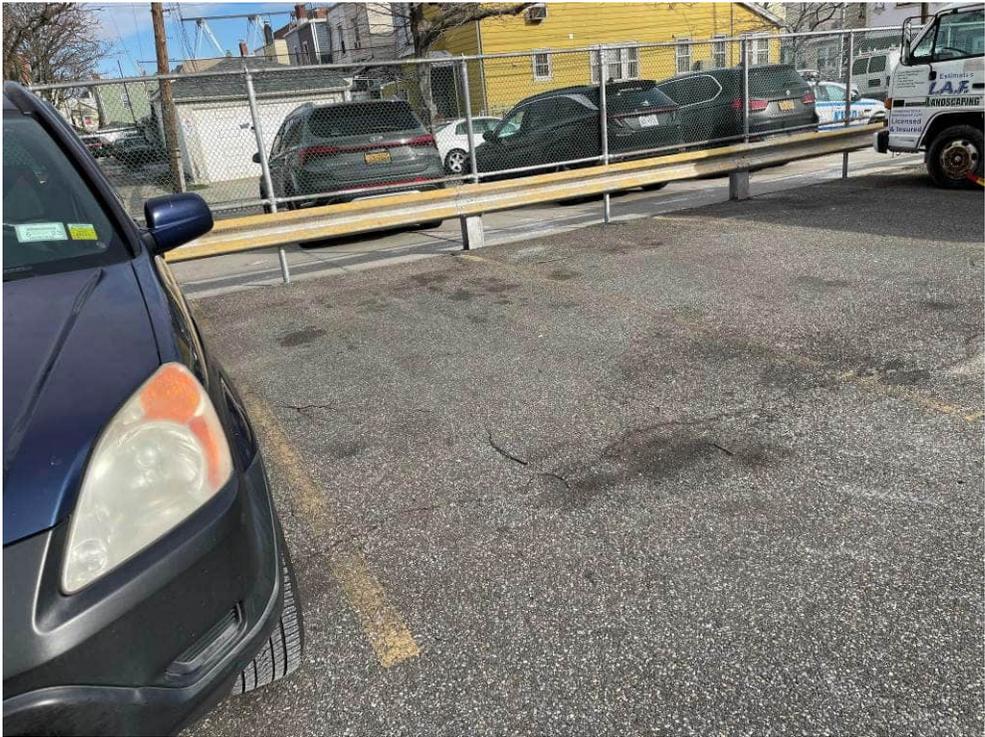
Photo No.: 12	Date: 03/15/23

Direction Photo Taken: Looking North		
Description: View of typical staining on asphalt pavement. Staining associated with parked vehicles and is de minimus.

- Minor areas of staining typically associated with parked vehicles were observed along the north, south and west sides of the parking lot on intact asphalt pavement; however, all stained areas are considered de minimis.

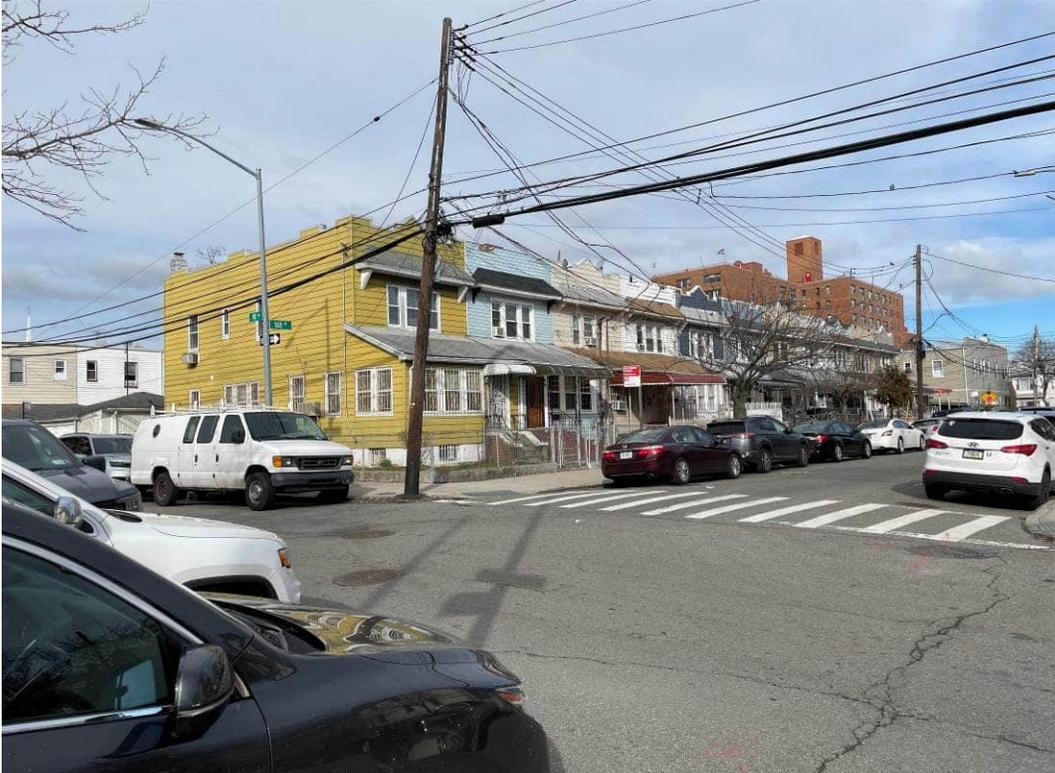
Client Name: MTA C&D		Site Location: 90-01 168 th Street, Jamaica, New York, 11432	Project No.: 60704499
Photo No.: 15	Date: 03/15/23

Direction Photo Taken: Northeast			
Description: Adjacent properties north of the site on the north side of 91 st Avenue.

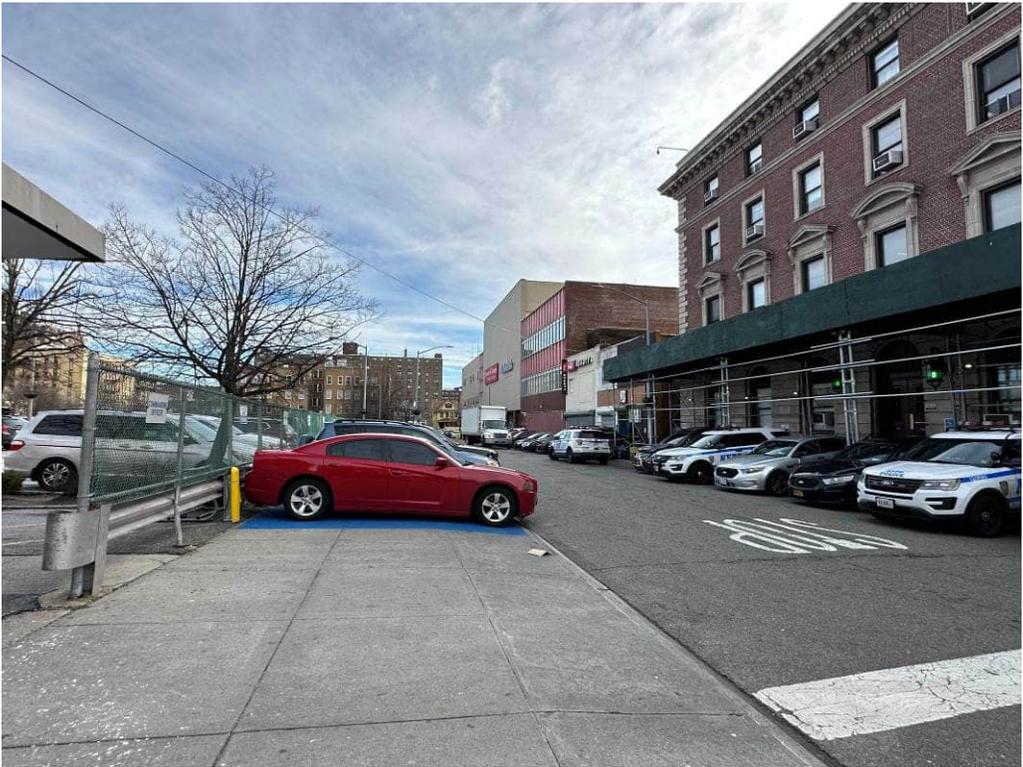
Photo No.: 12	Date: 03/15/23

Direction Photo Taken: Looking East		
Description: View of 91 st Avenue and off-site (front to back) Police 103 building, and retail stores including Marshall's, and Raymour & Flannigan. .

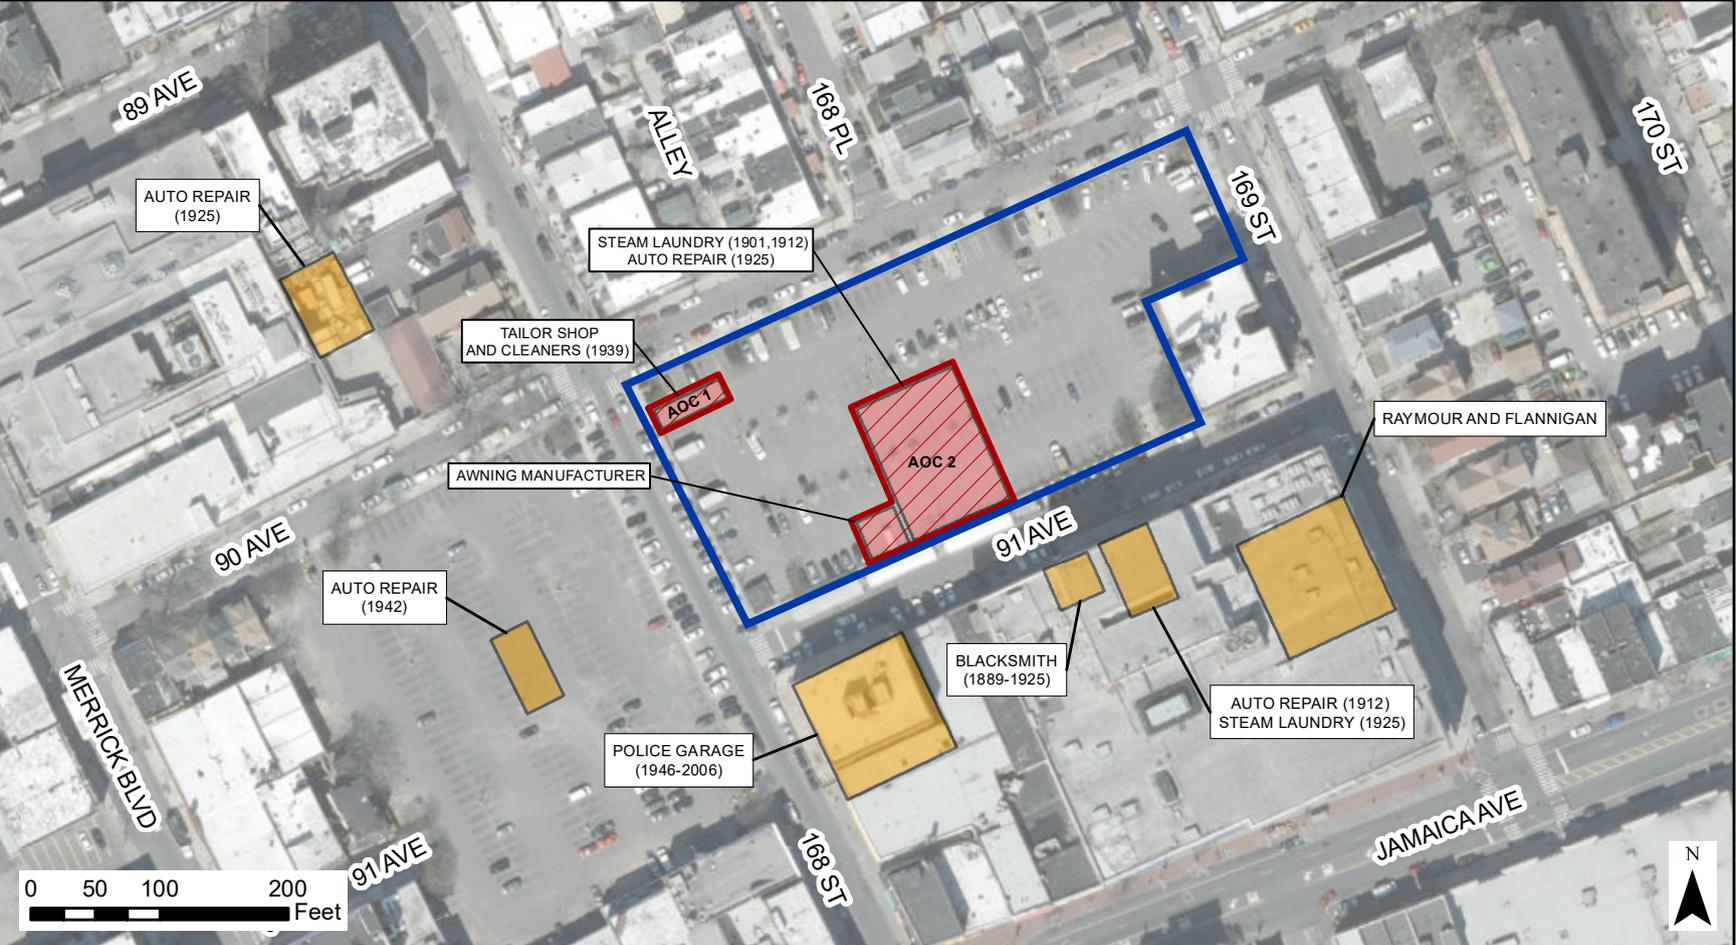
Figure 2: Study Area RECs

- Project Site
- Area of Concern (AOC)
- Historic On-Site Recognized Environmental Condition (REC)
- Historic Off-Site Recognized Environmental Condition (REC)

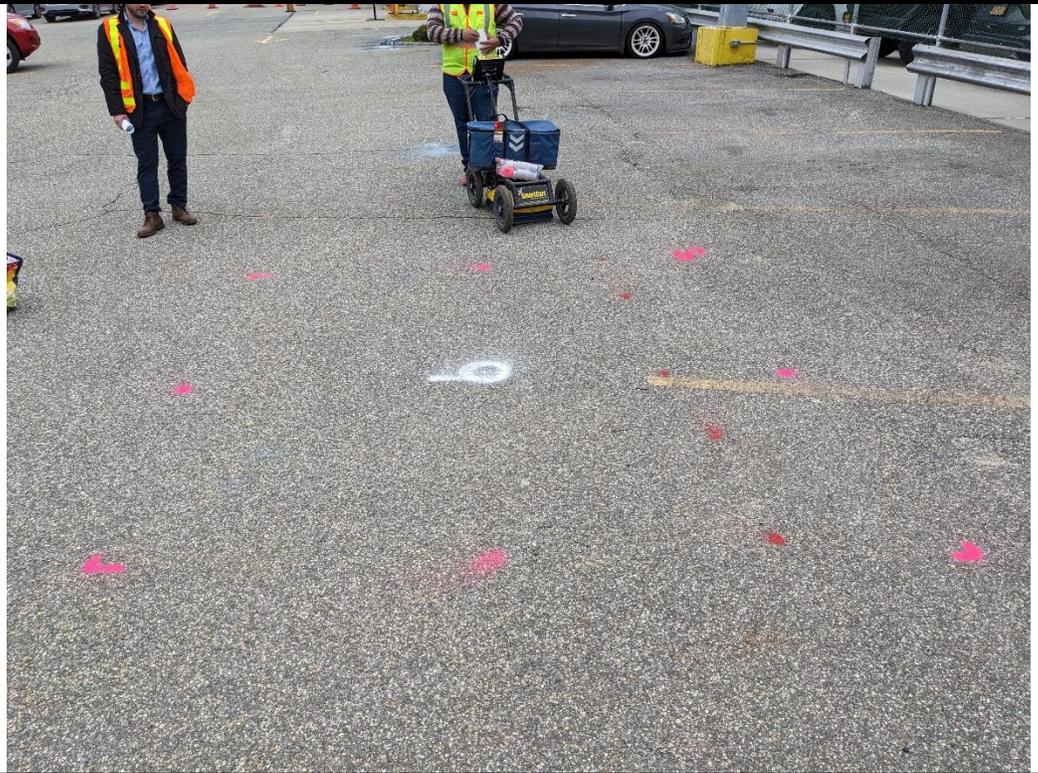
There is likely a concrete pad a little south of the painted number.

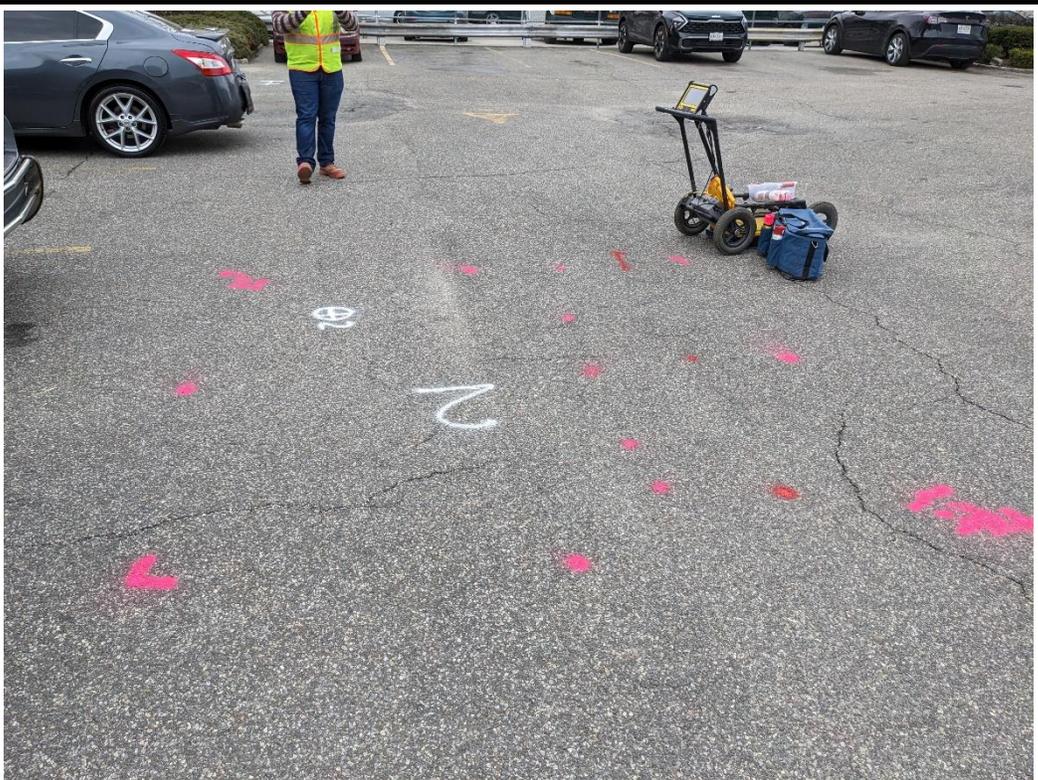
The red dotted line denotes where there was an electrical interference

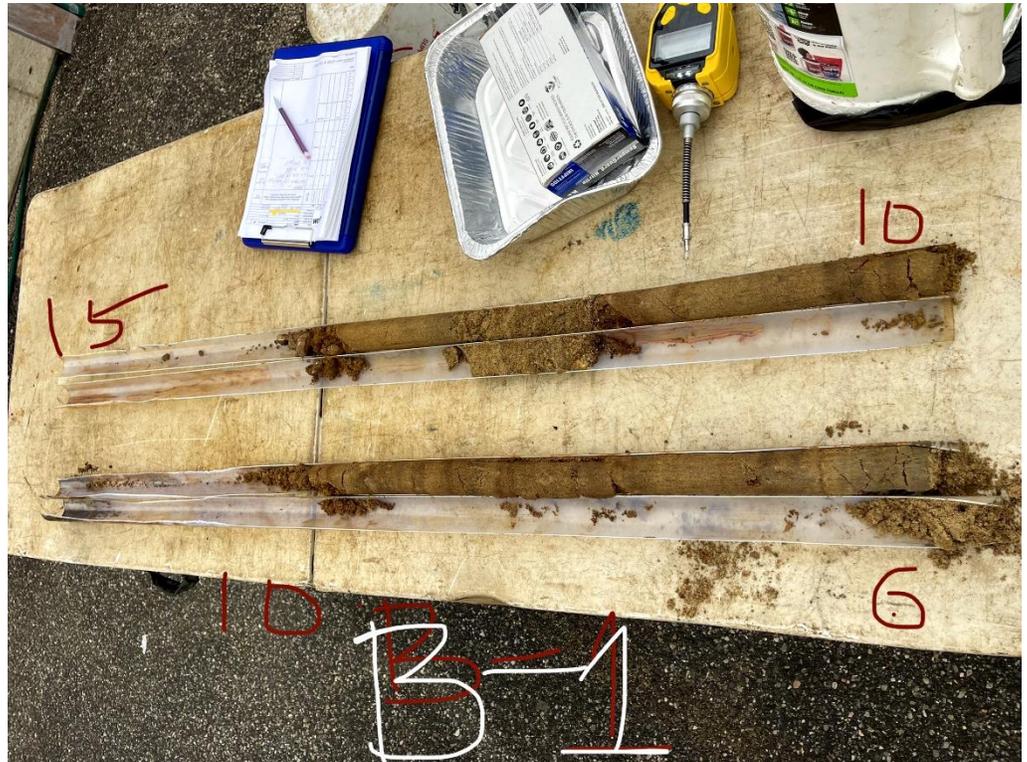
Representative photograph of soils encountered in the boring identified as B-1

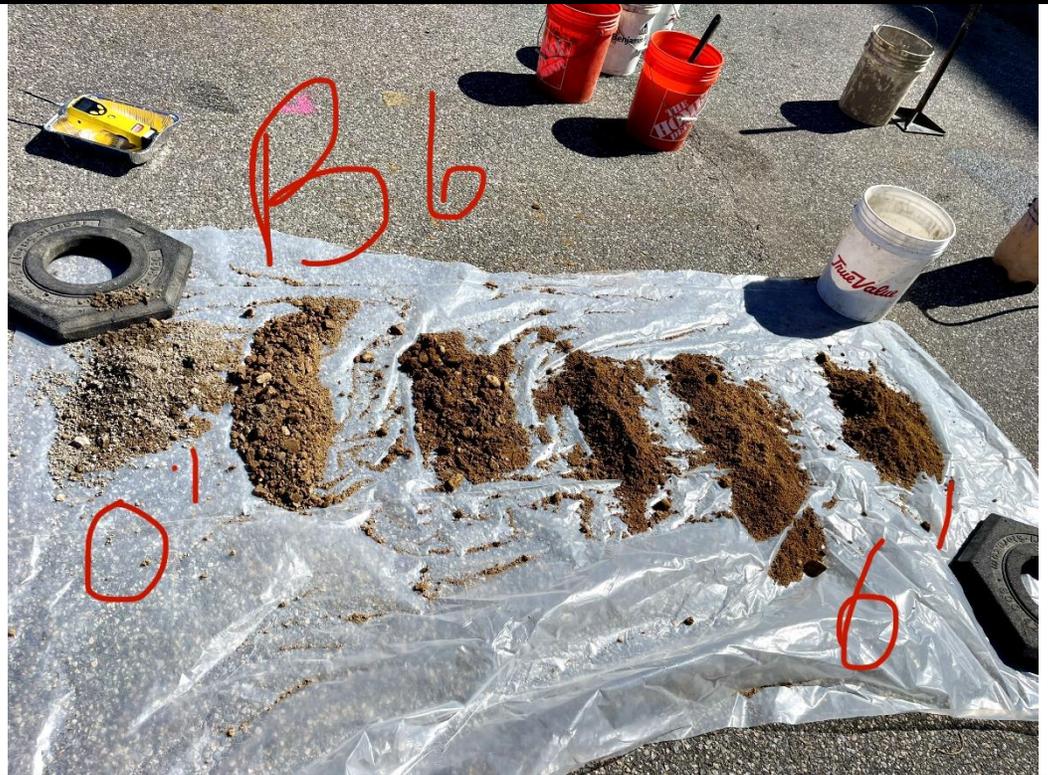
Representative photograph of soils encountered in the boring identified as B-6

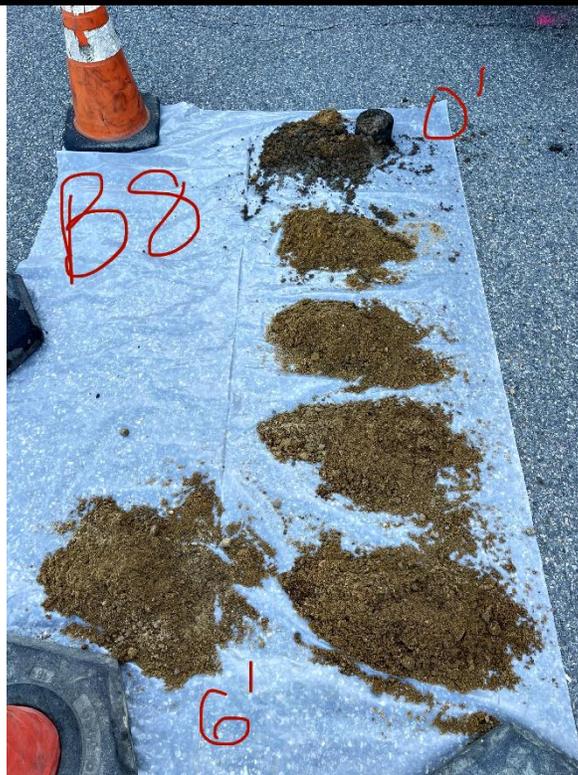
Representative photograph of soils encountered in the boring identified as B-8

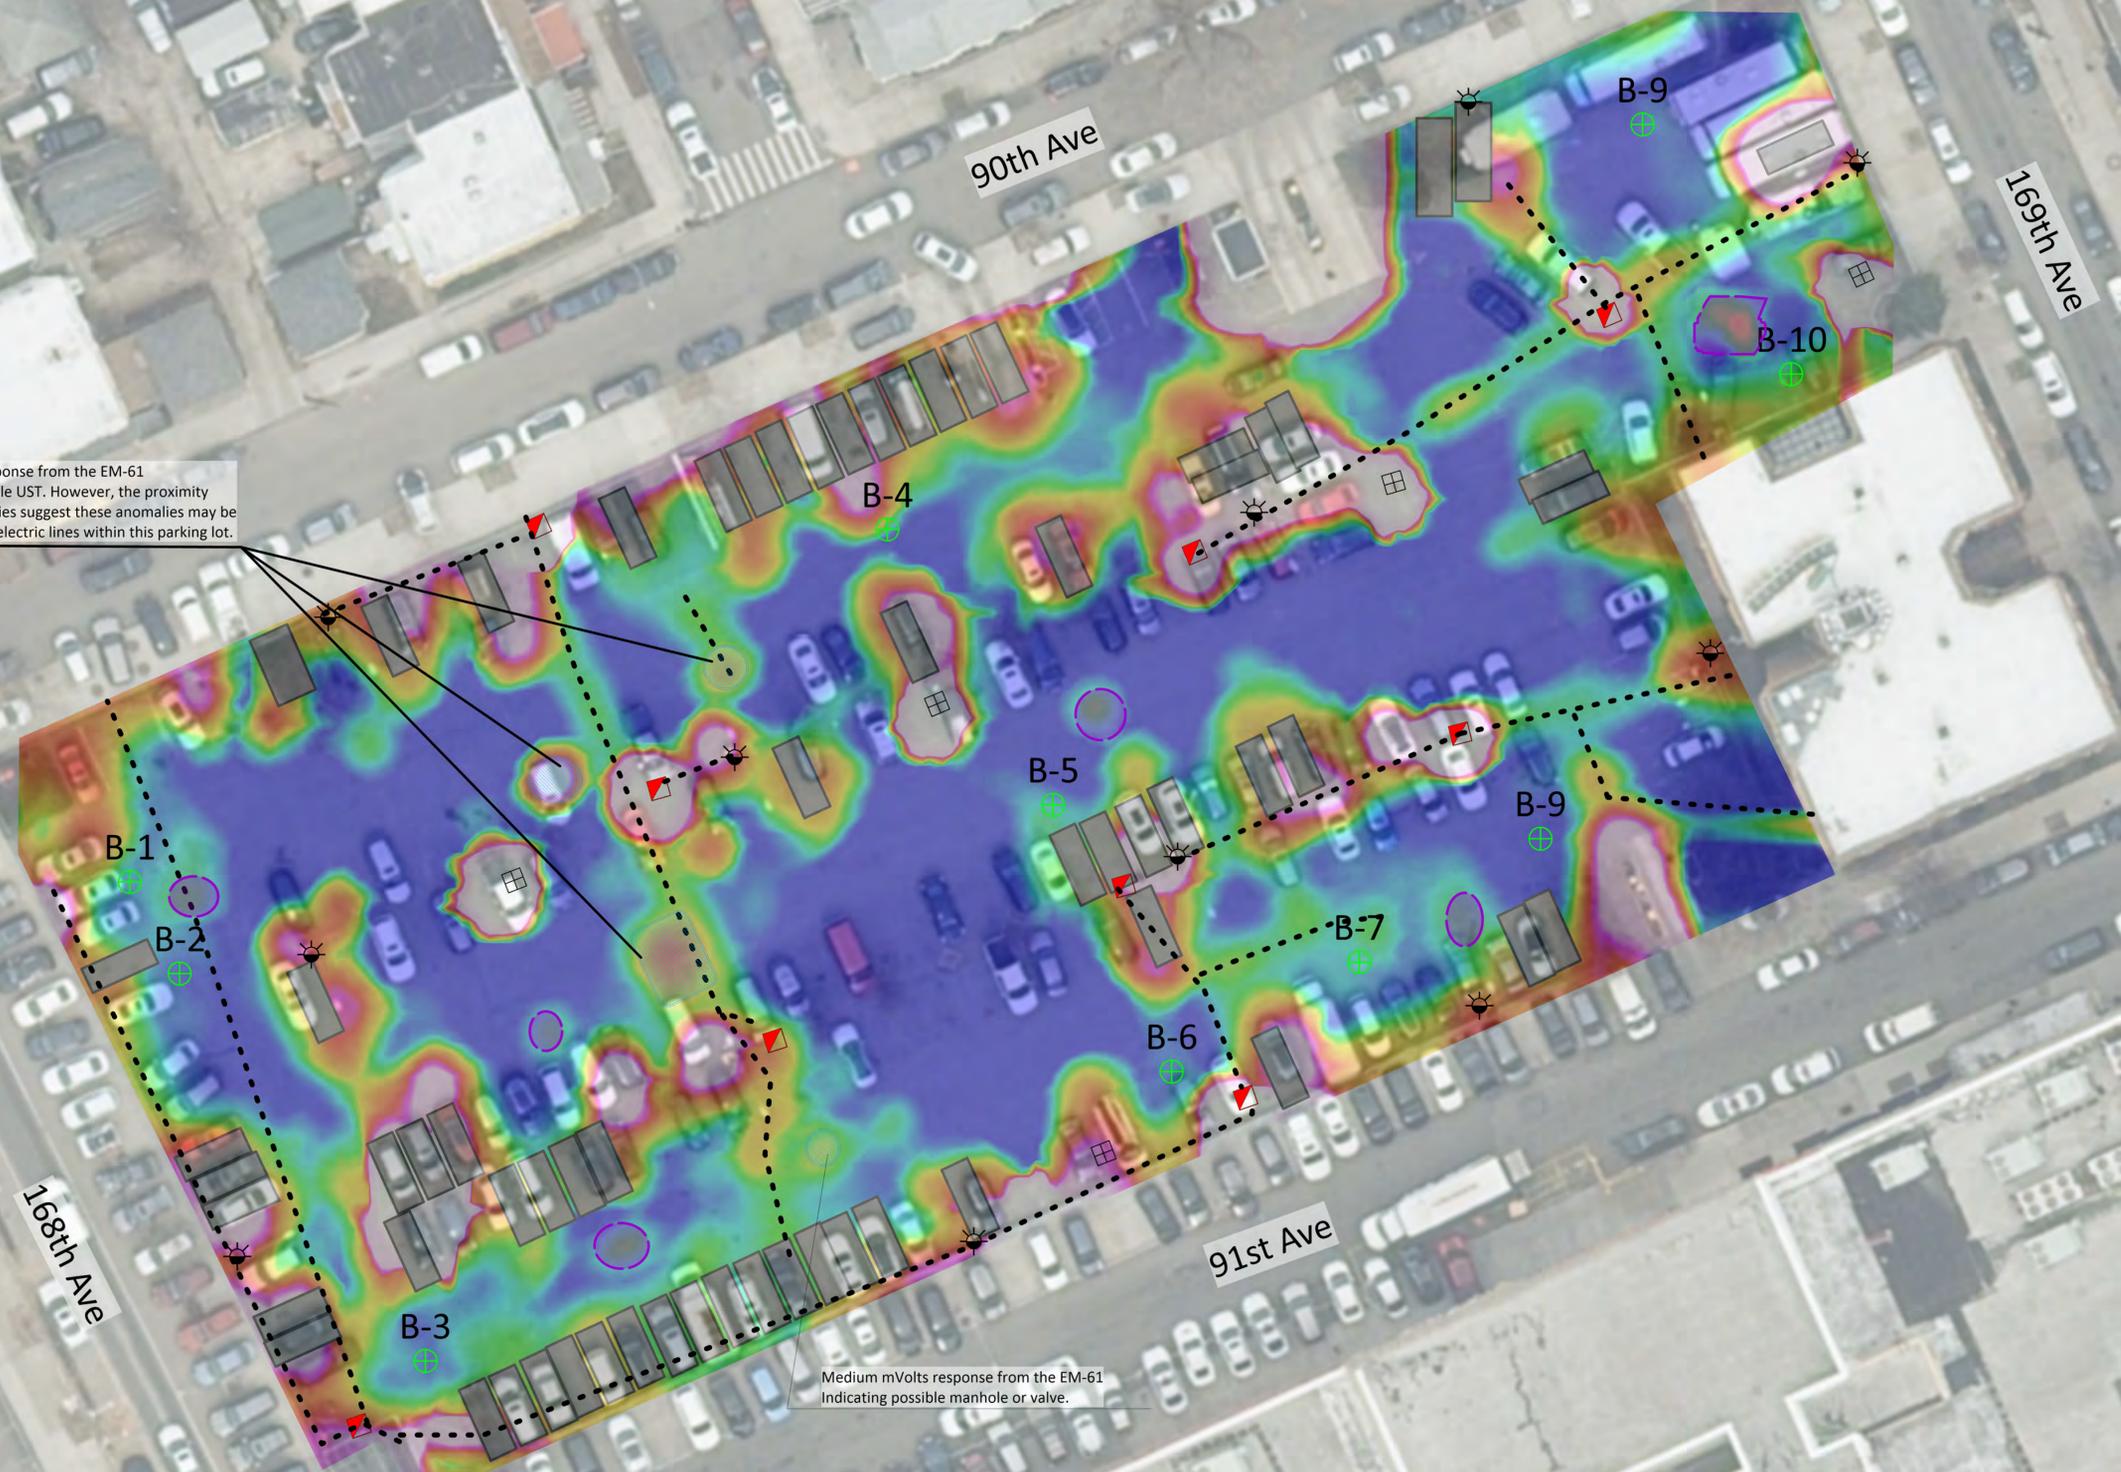
BOTTOM COIL MEASUREMENTS (mVolts)
