Appendix C Phase I and Phase II Environmental Site Assessments 168th Street Interim Bus Terminal

Phase I Environmental Site Assessment

Proposed MTA Jamaica Bus Terminal Facility

90-01 168 Street
Queens, New York
(Block 9800, Lot 5)

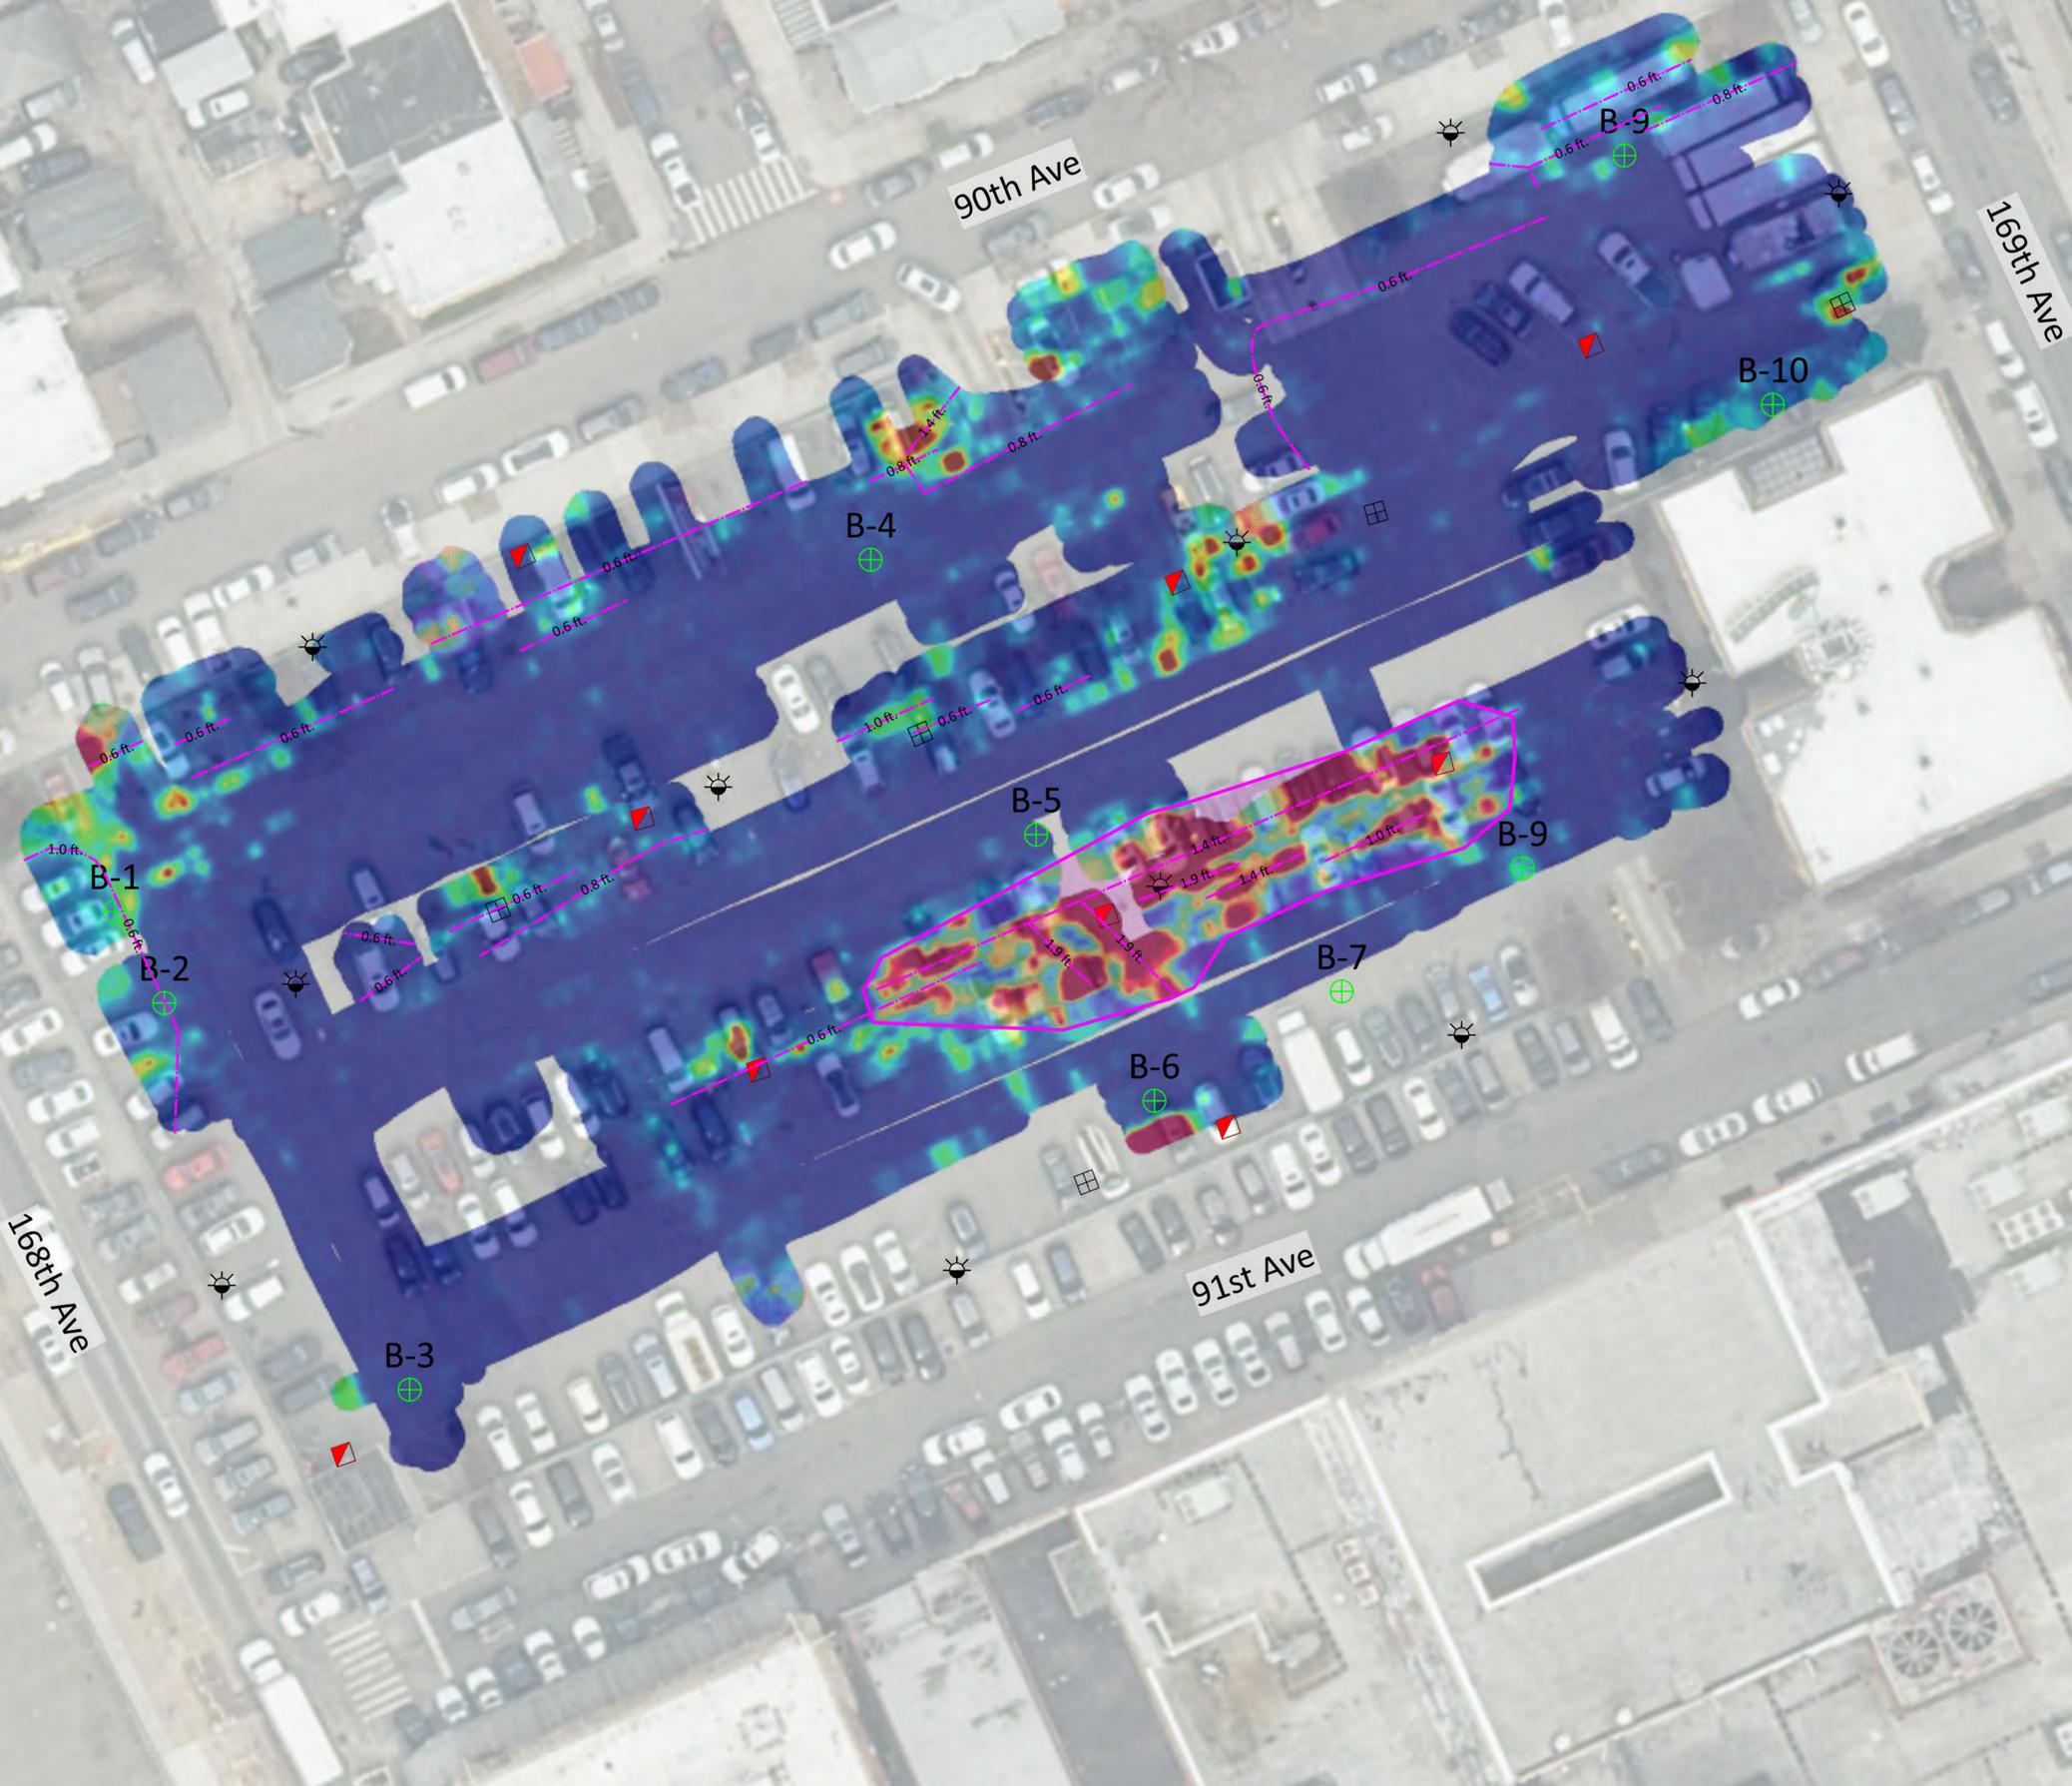
DEPTH: 1.9 ft. to 2.3 ft.

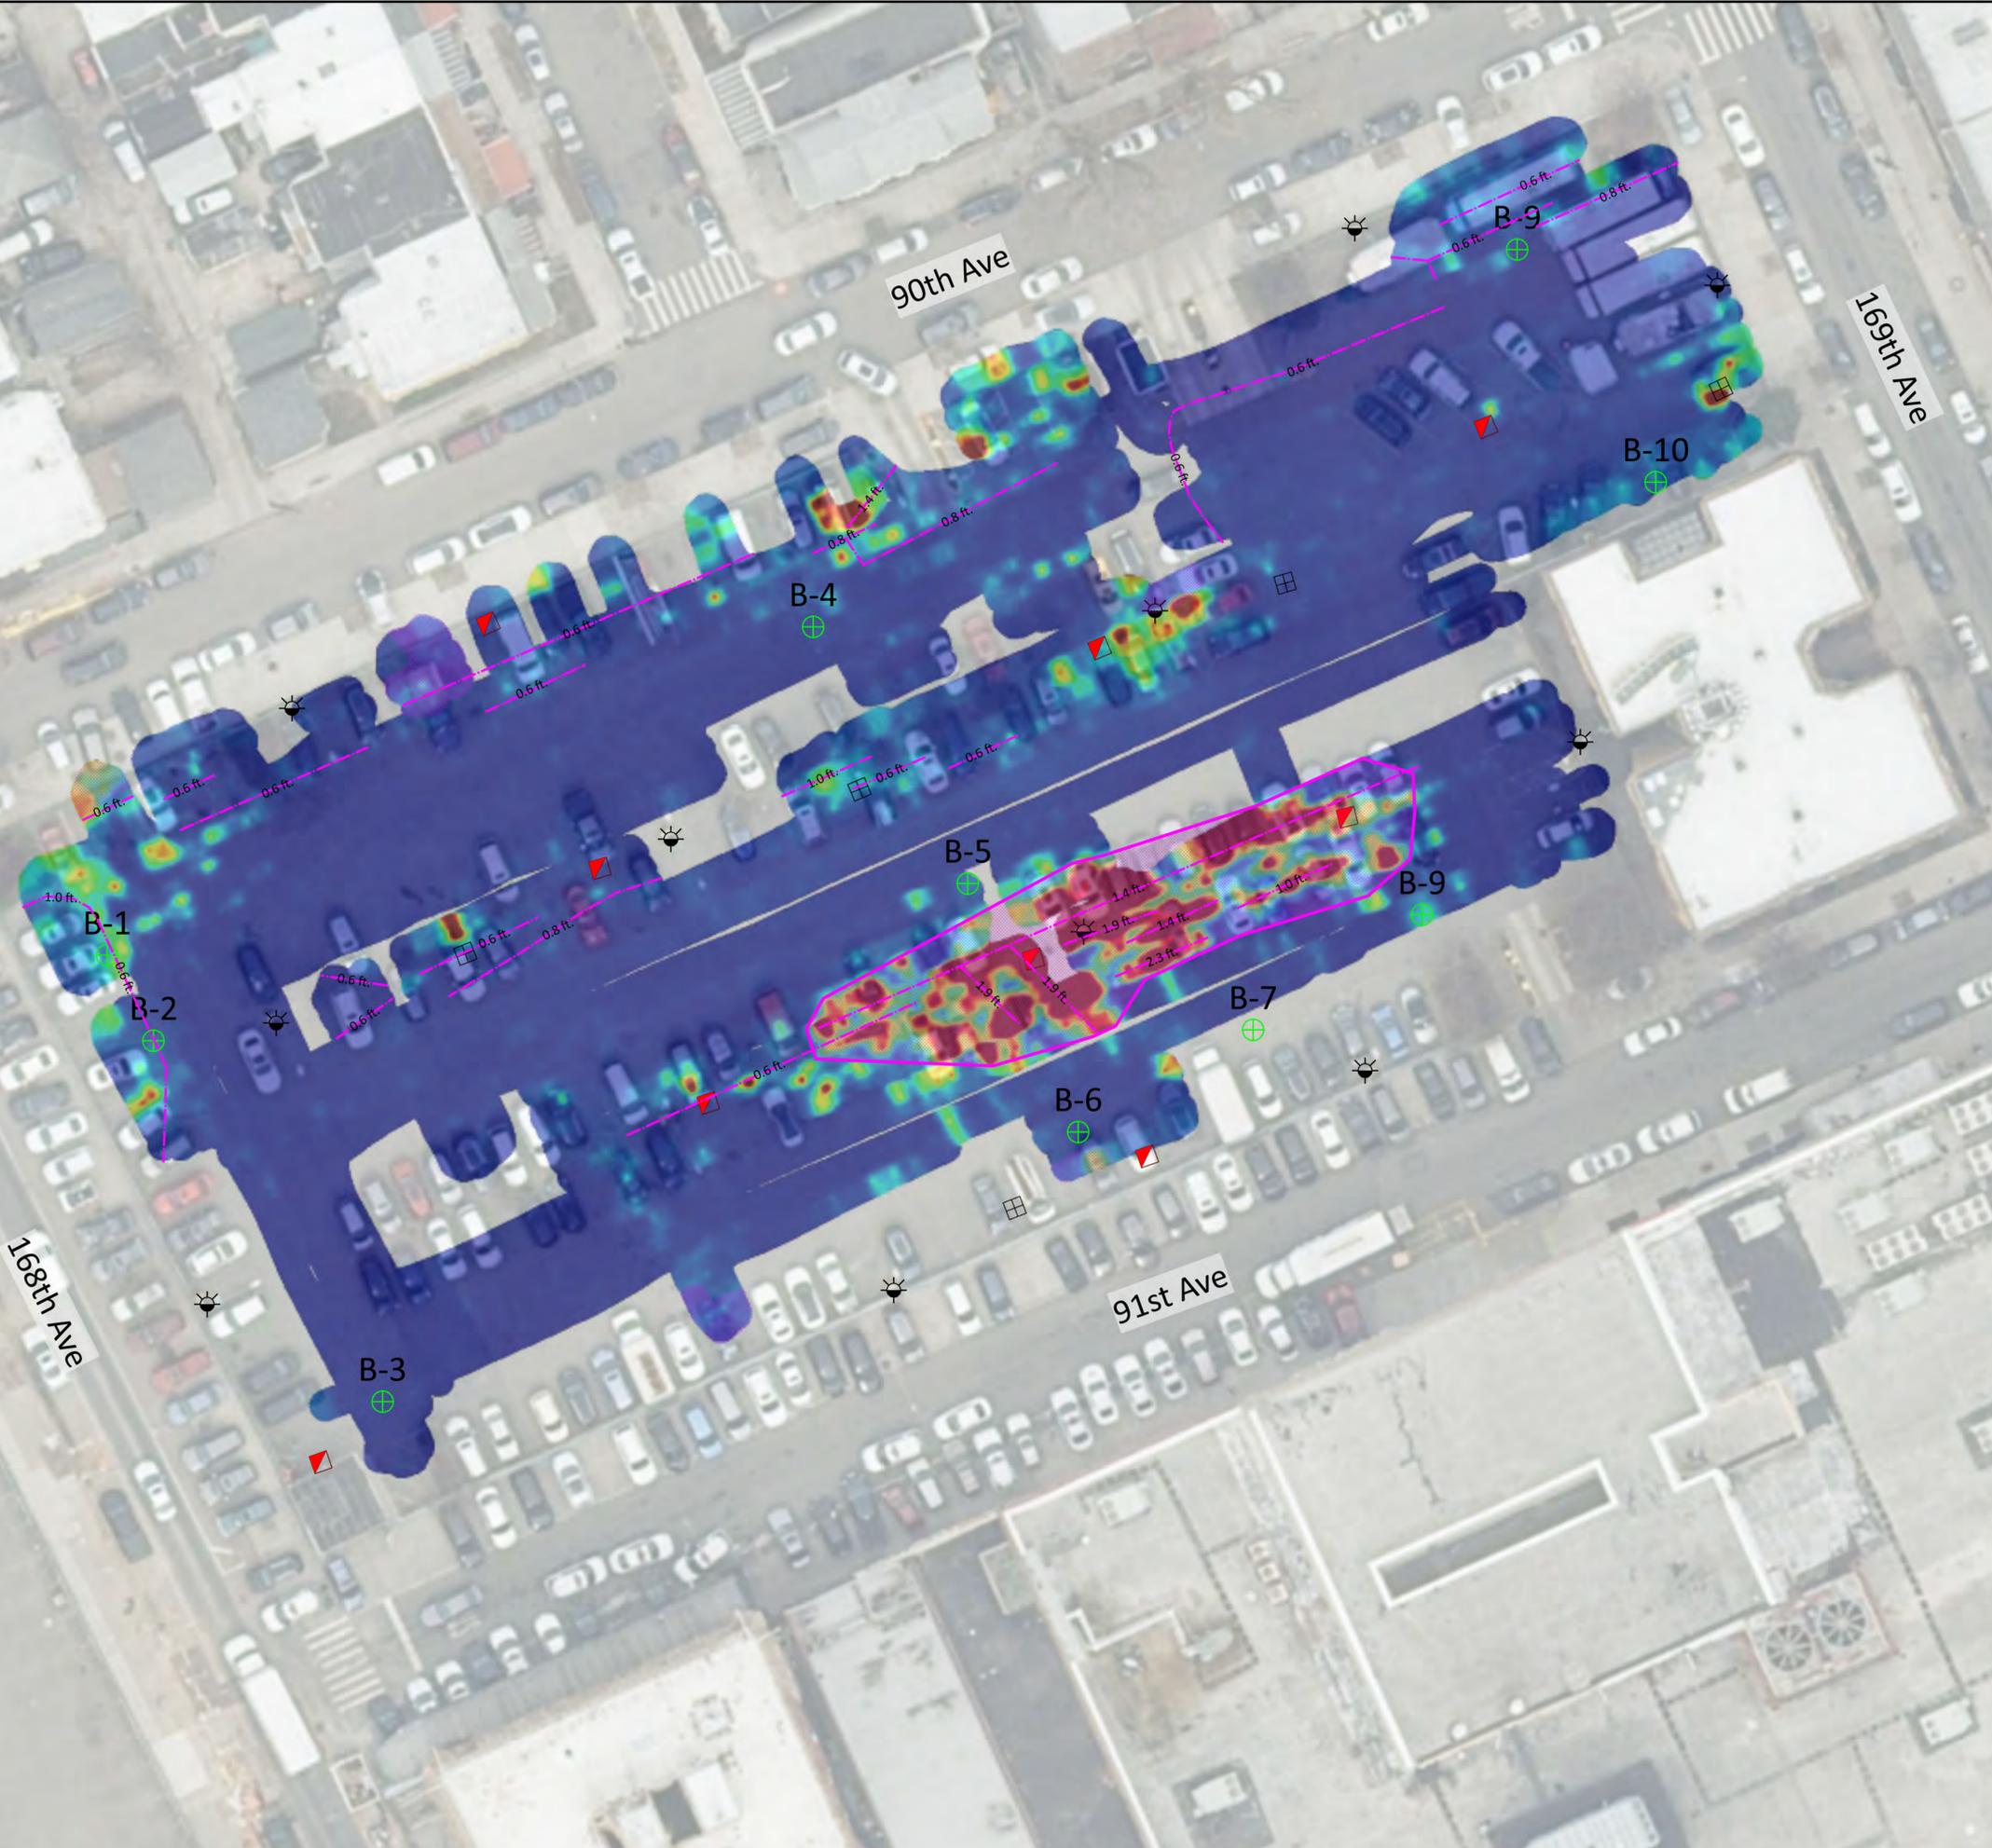
DEPTH: 2.3 ft. to 2.7 ft.

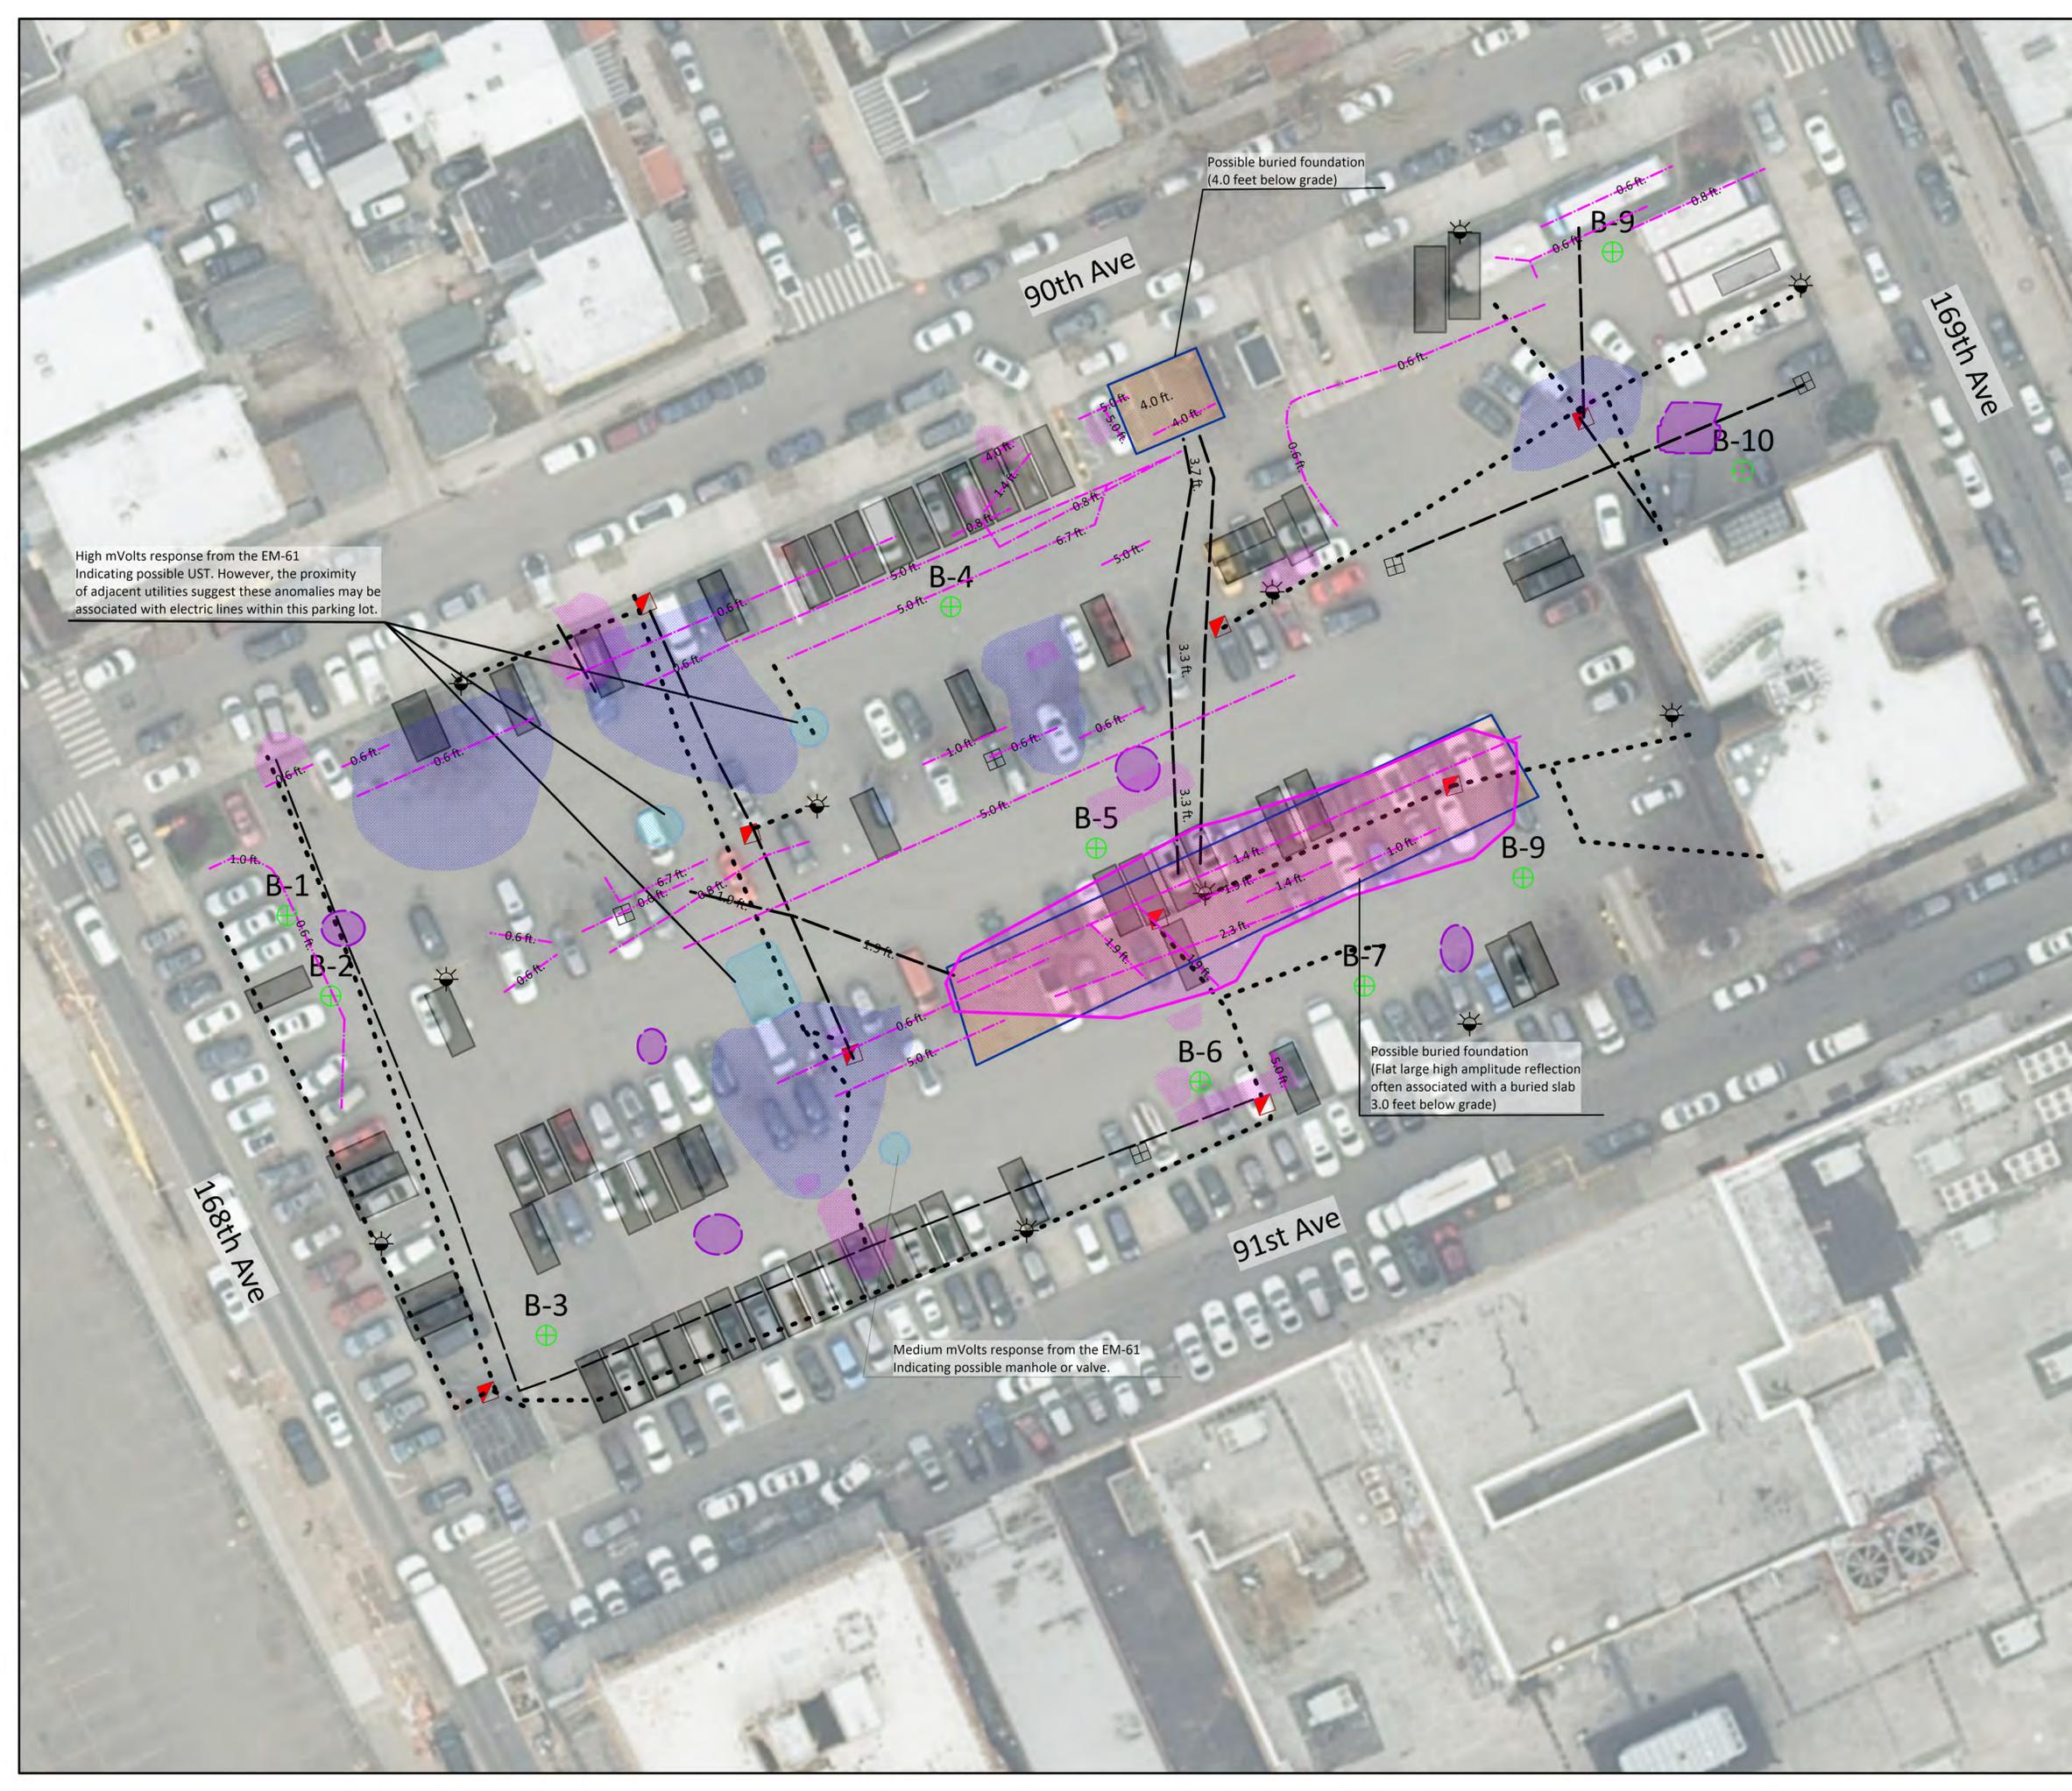
Possible buried foundation
(Flat large high amplitude reflection
often associated with a buried slab
3.0 feet below grade)

Medium mVolts response from the EM-61
Indicating possible manhole or valve.
